Material in this publication relating to
DUAL ORIFICE INJECTION, LAMINATED
CHAMBER COOLING MEANS, and A VARIABLE
AREA INJECTOR CONCEPT

(U) The electrical ignition systems were also defined as a part of the control task and these systems are described in this Section. The ignition system performance is reported in the preburner and main burner test Sections.

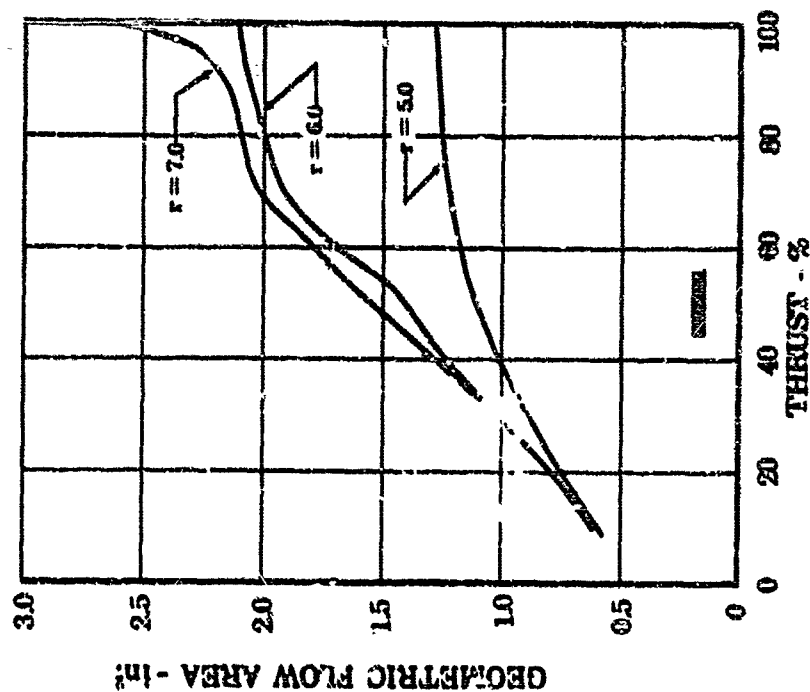
Figure 218. Required Geometric Flow Area vs Percent Thrust (Mixture Ratio Valve)

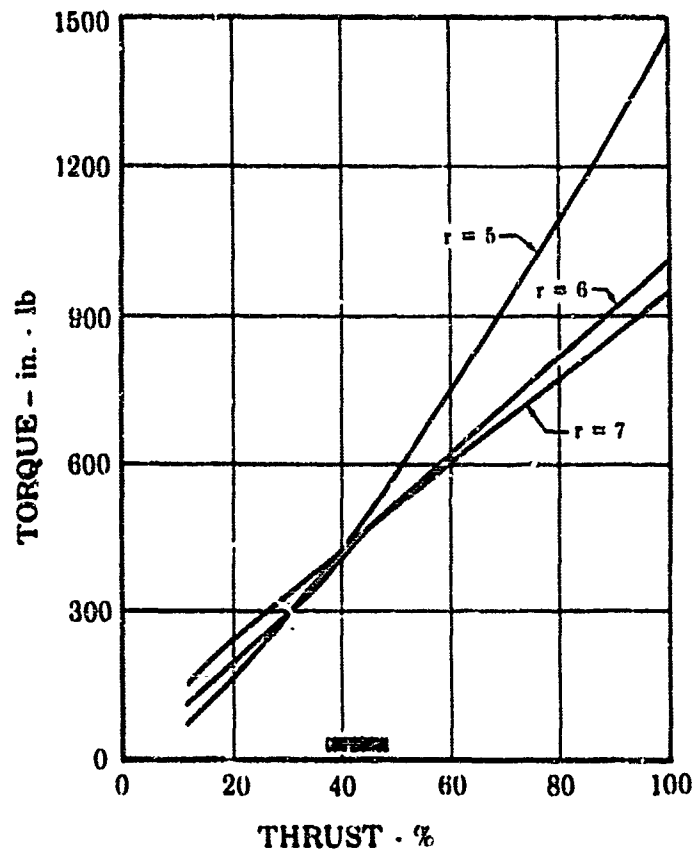
Figure 231. Dynamic Torque vs Percent Thrust (Ball Valve)

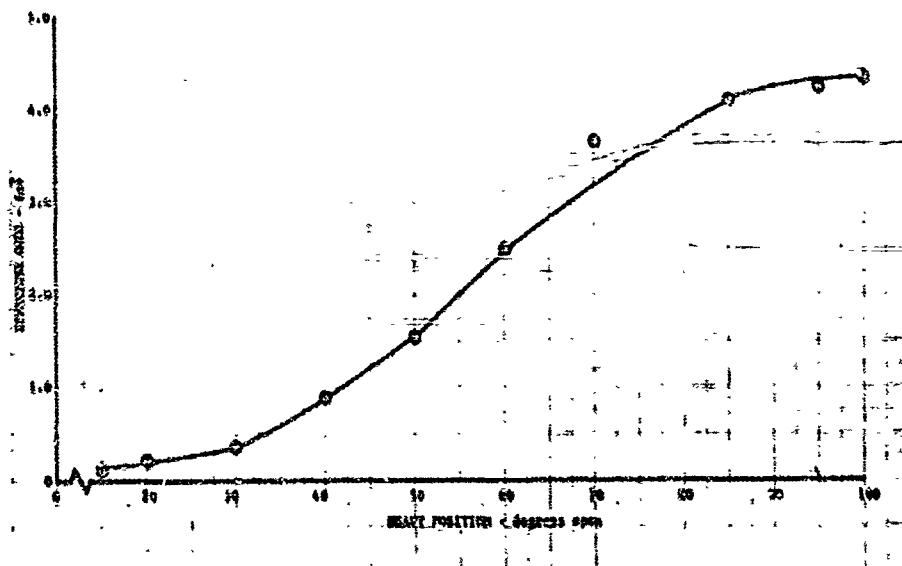
Figure 262. Mixture Ratio Valve Effective Area vs Shaft Position.
Rig F-33466-4

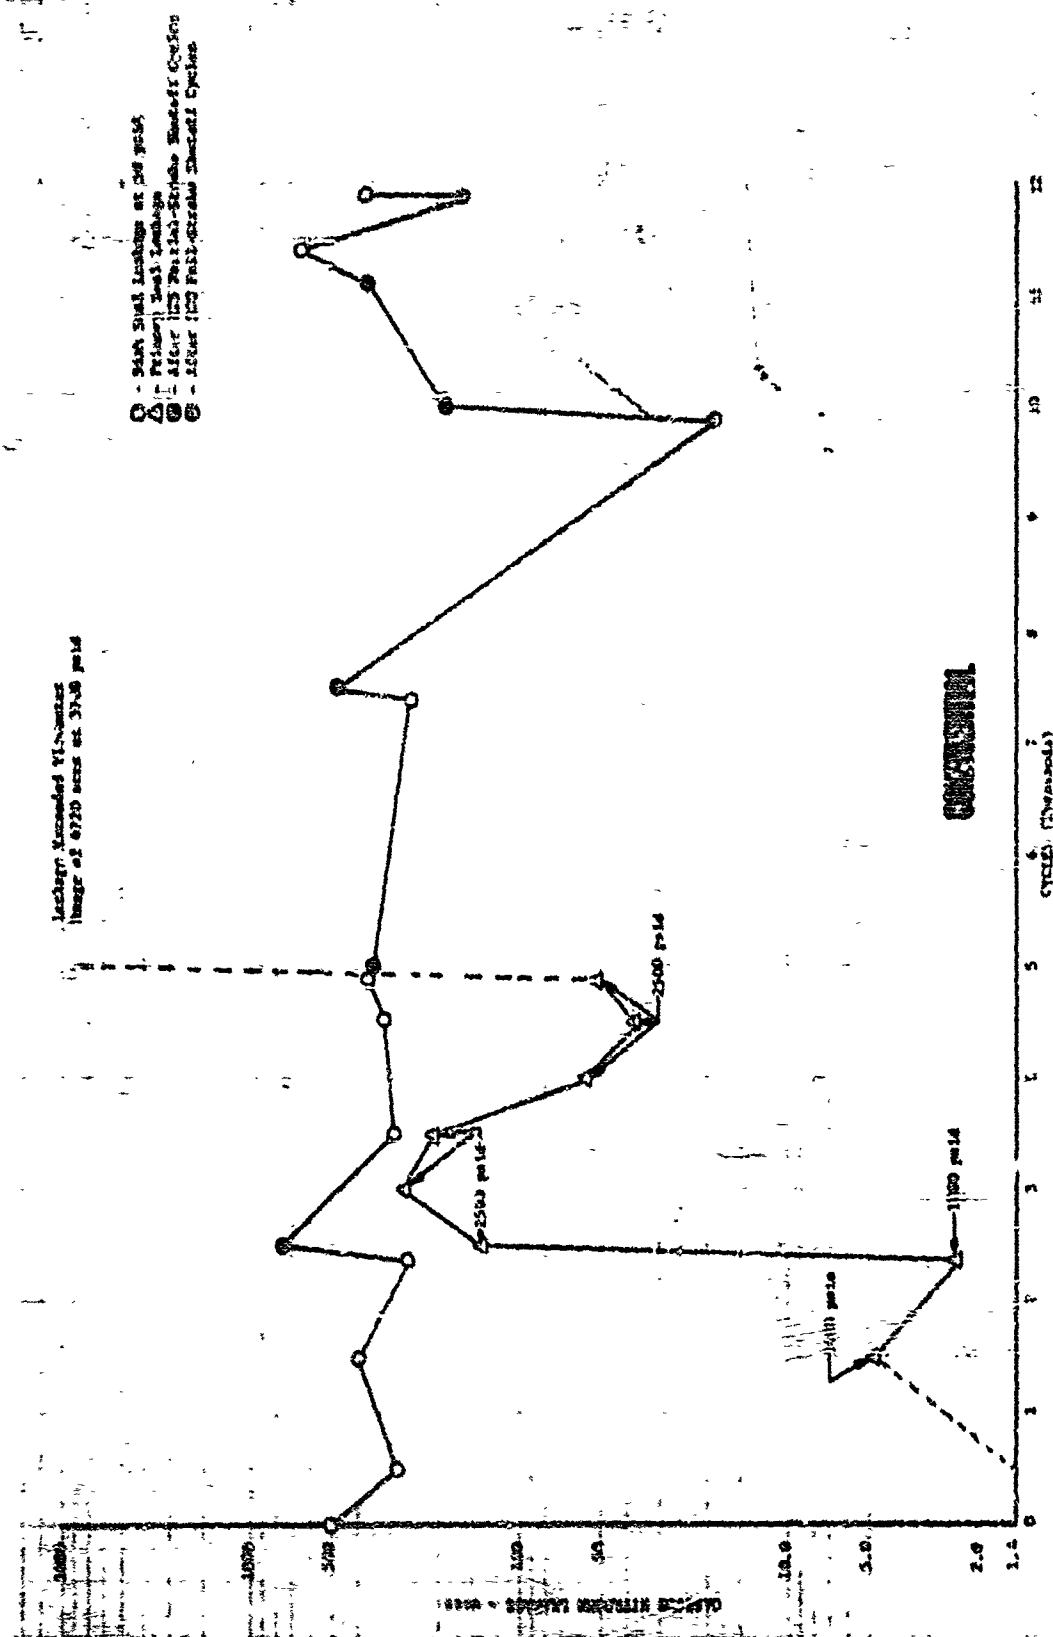
Figure 263. Leakage vs Cycles, Mixture Ratio Valve Rig F-33466-5

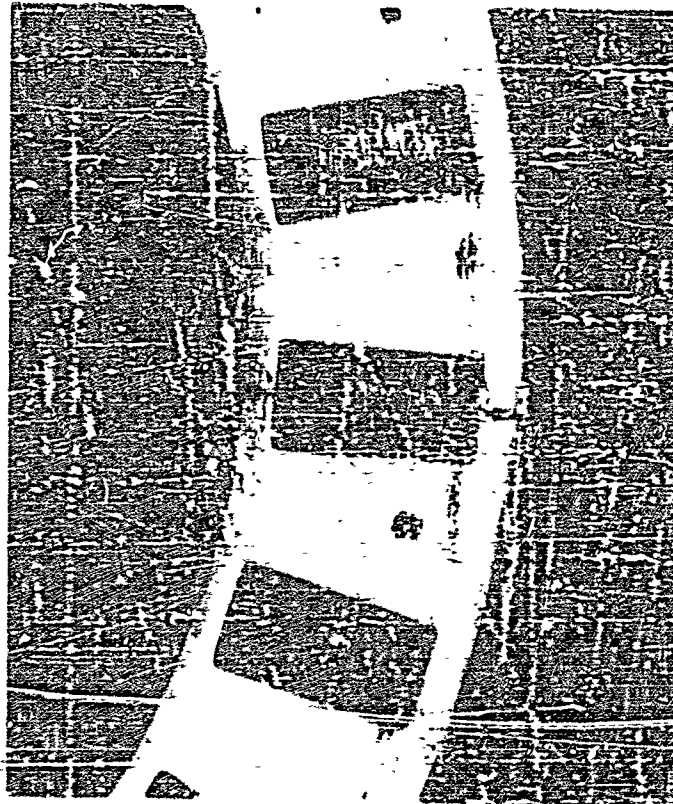
(C) Valve disassembly after the test revealed that all parts were in good condition and capable of continued testing. The lower thrust bearing, figure 270, had galled with the thrust washers and spacer. The shaft and shaft disk were in good condition as shown in figure 271. However, the inside diameter of the disk seal was slightly frayed as shown in figure 272. The primary lip seal was in excellent condition as shown in figure 273.

Figure 270. Lower Thrust Bearing After Test
of Rig F-33466-5

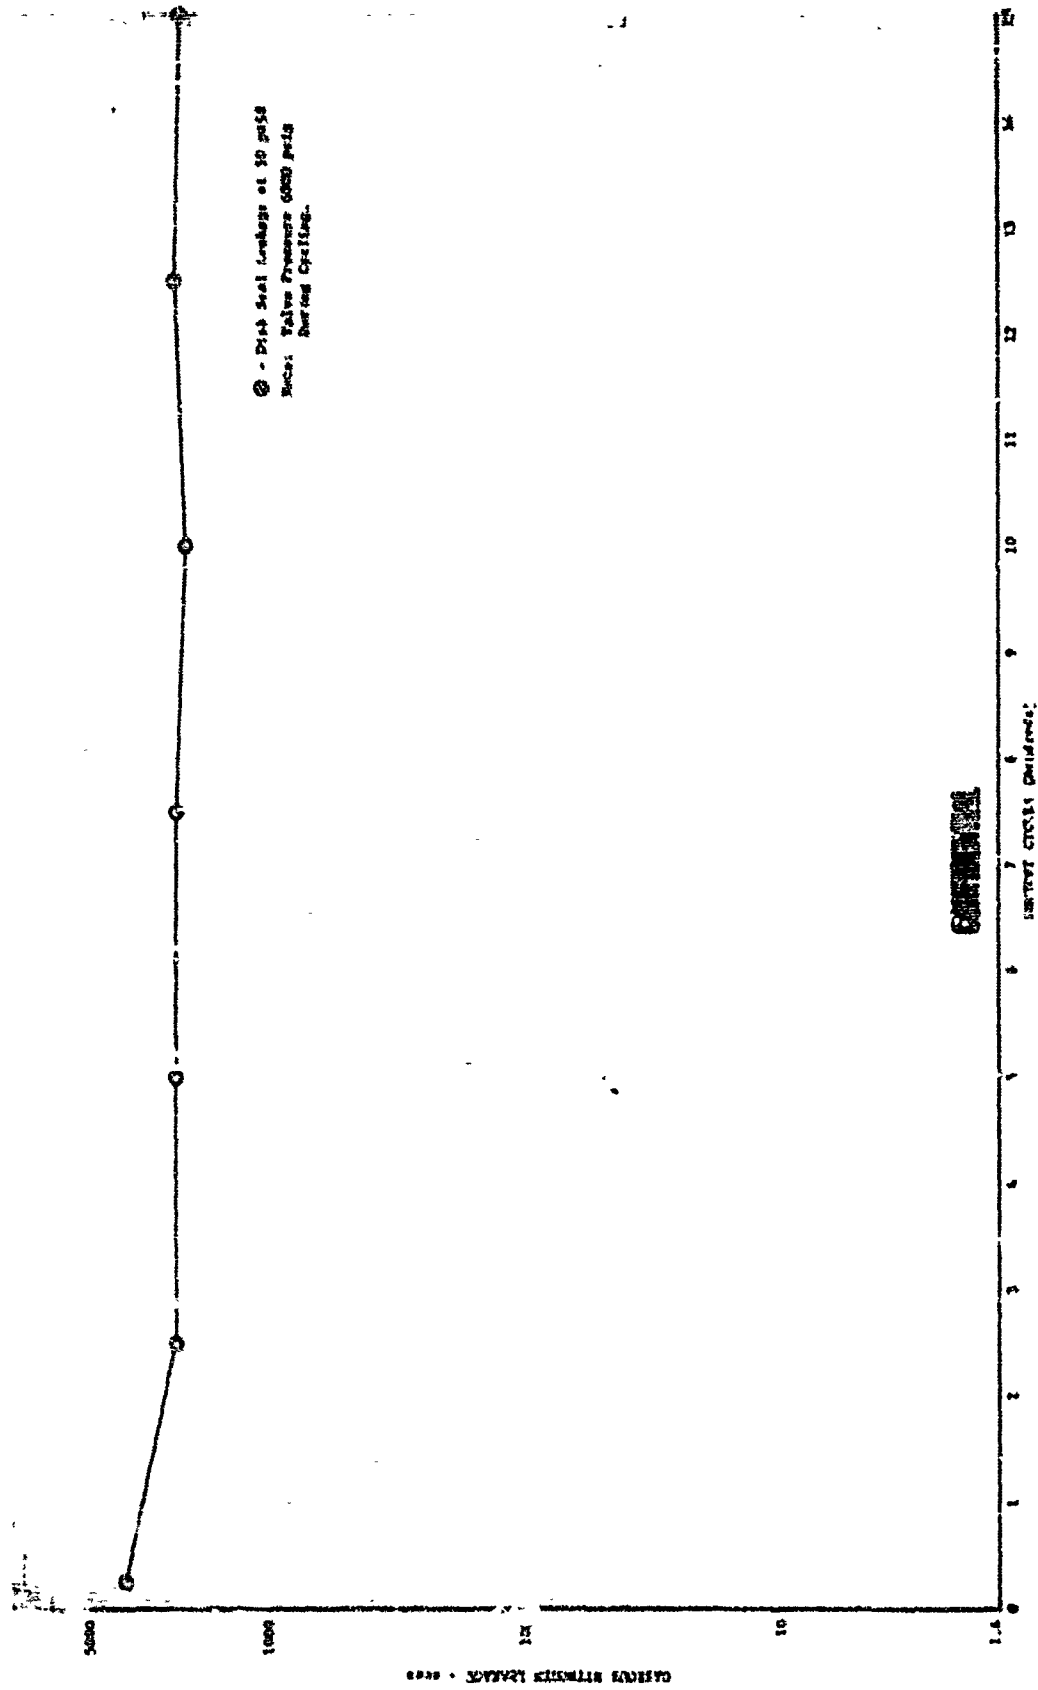
Figure 274. Disk Seal Leakage vs Shaft Cycles, Mixture Ratio Valve, Fig F-33466-6

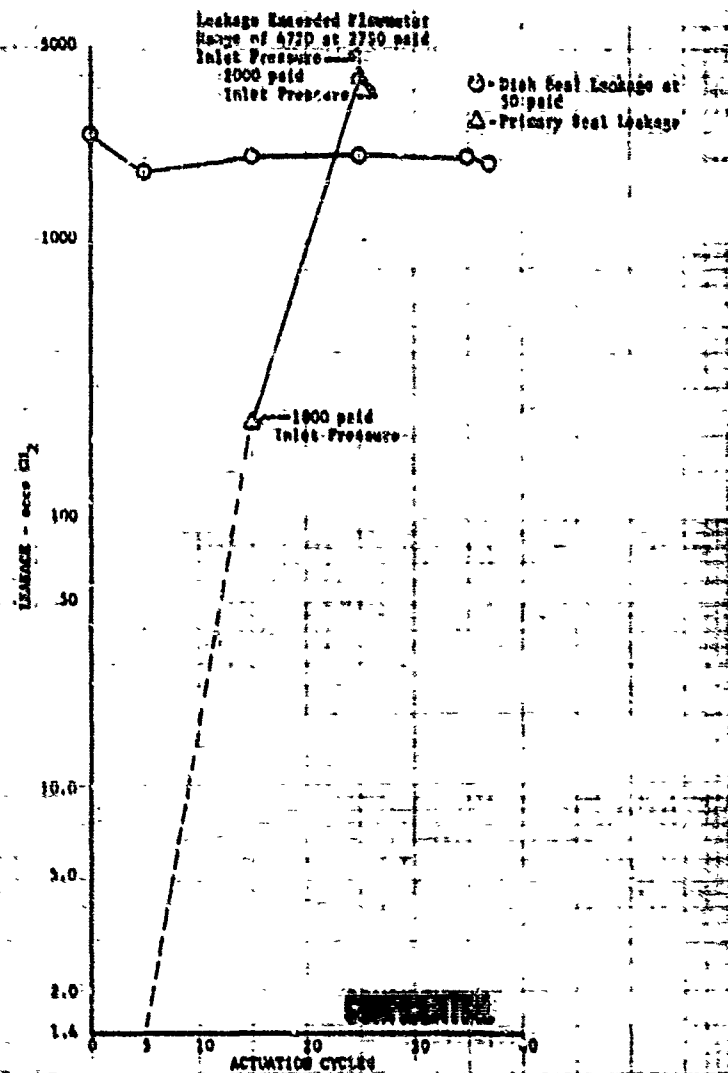
(C) Disk seal leakage at 50 psia and primary seal leakage are illustrated in figure 278. The primary seal vent was capped when the leakage exceeded the flowmeter range, as indicated. The outlet primary O-ring leakage exceeded the flowmeter range at 1000 psig and was capped. The maximum inlet static seal leakage was 193 sccs. The secondary and vent seal leakage remained less than 1.4 sccs throughout the run. Average valve response to a step input was 1.04 milliseconds/degree.

Figure 278. Leakage vs Actuation Cycles, Rig F-33466-7

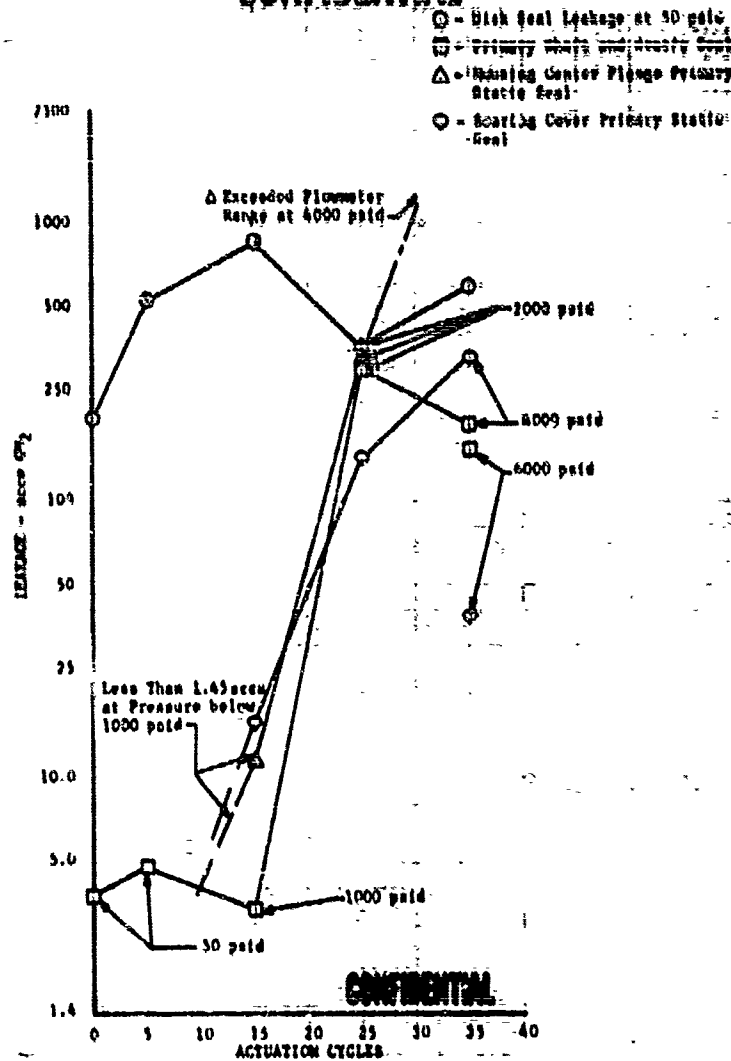
Figure 279. Leakage vs Actuation Cycles, Rig F-33466-8

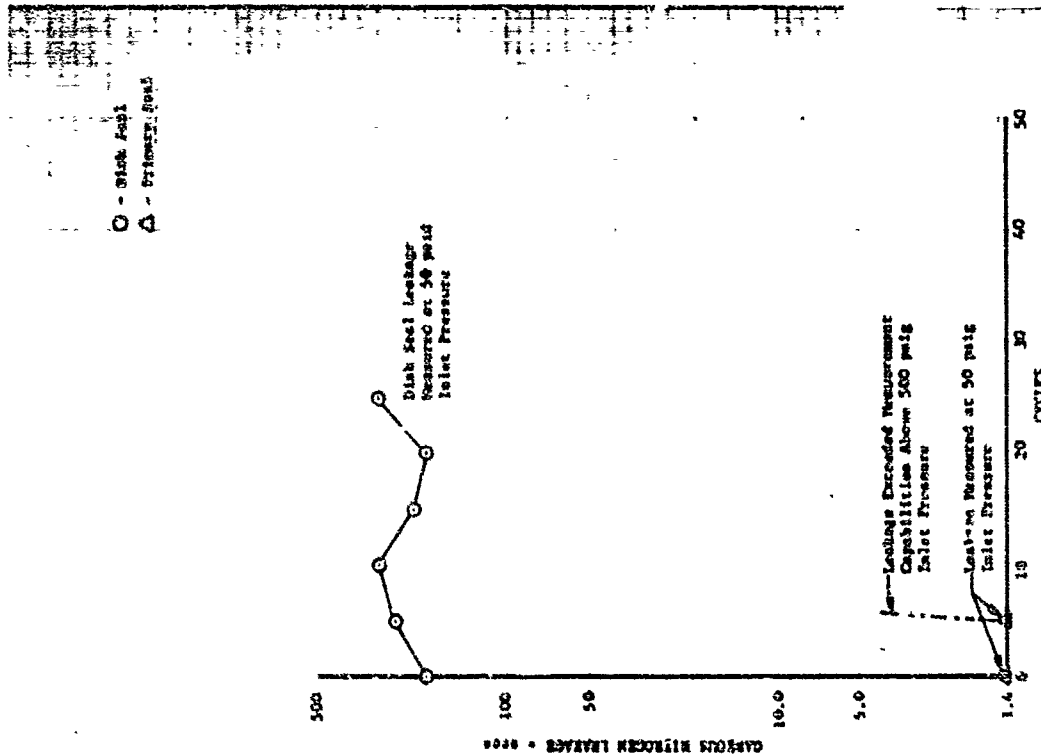
Figure 289. Leakage vs Cycles, Mixture Ratio Valve Rig F-35106-4 DF 58768

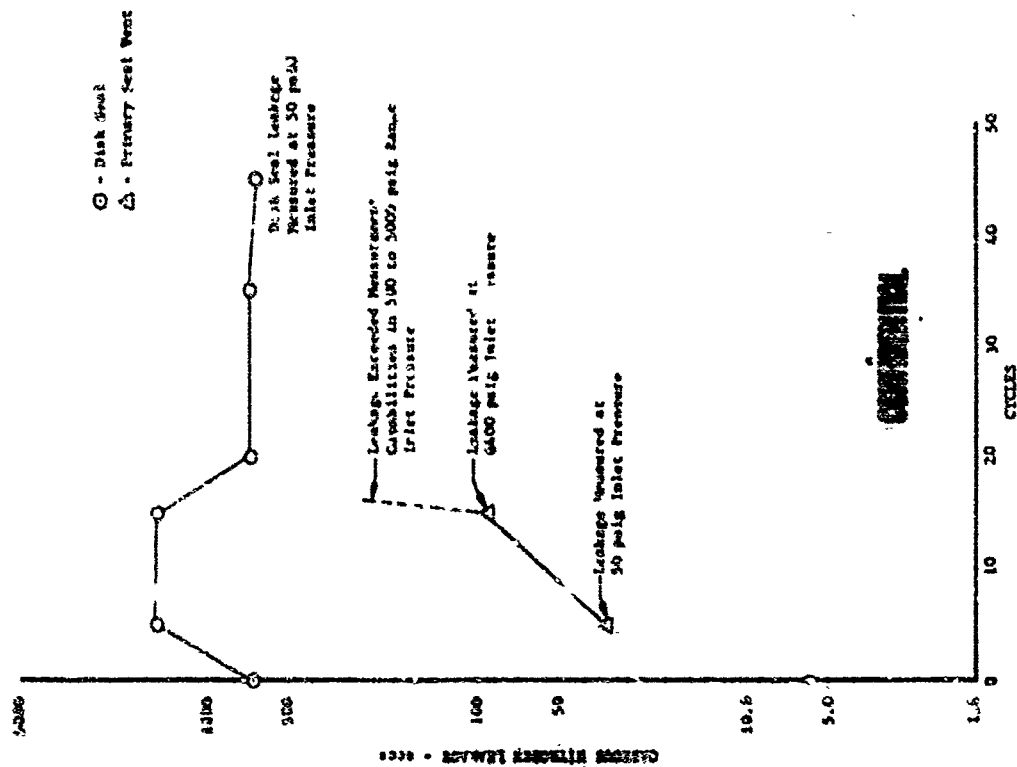
Figure 288. Leakage vs Cycles, Mixture Ratio Valve Rig F-35106-3 DF 58767

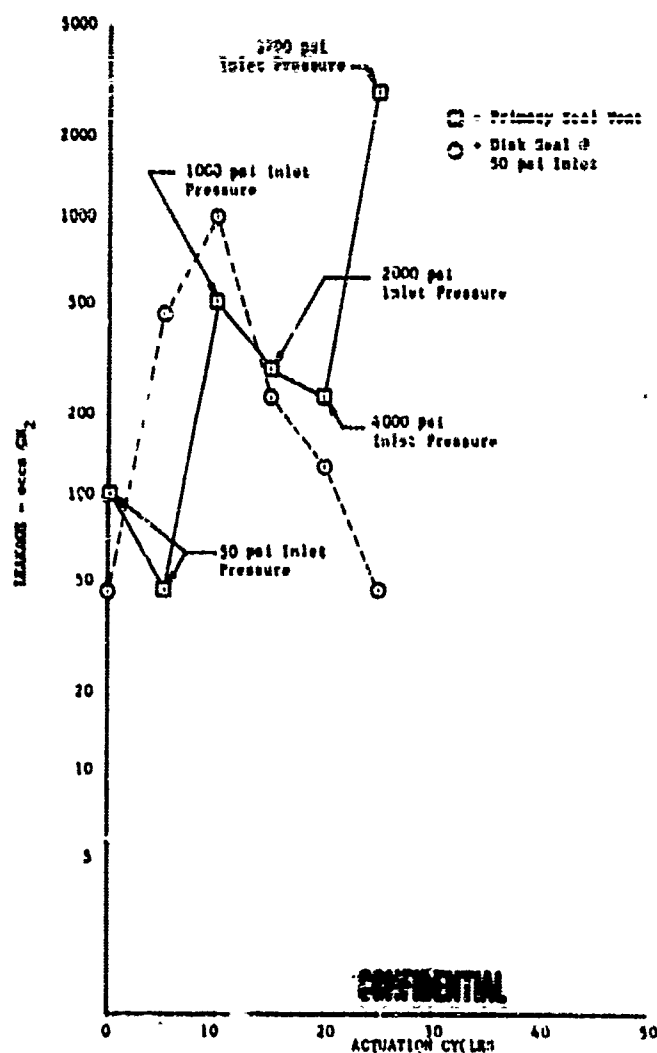
Figure 290. Leakage vs Cycles, Mixture Ratio
Valve Rig F-35106-5

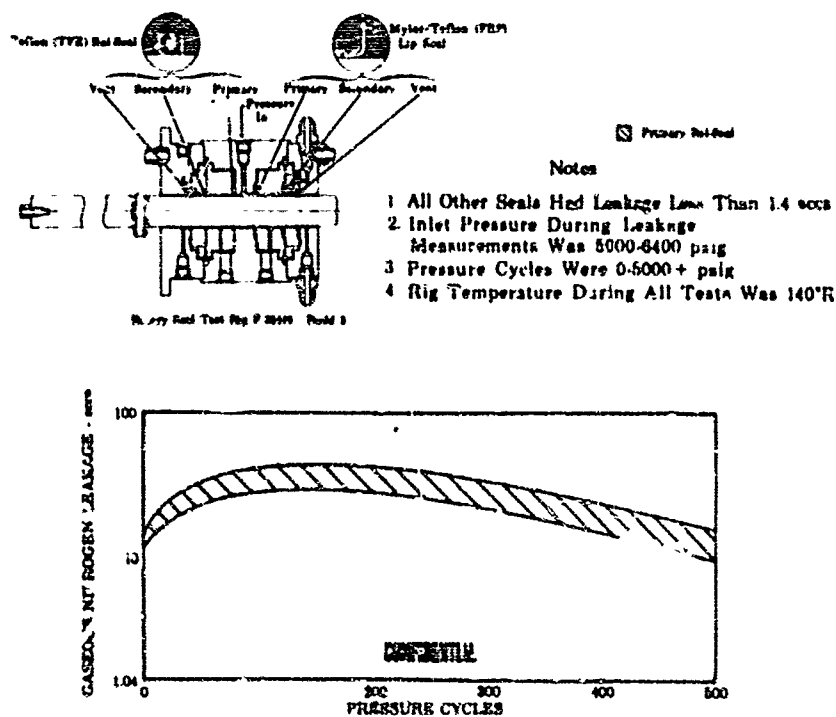
Figure 294. Rotary Shaft Seal Test Rig Leakage vs Cycles for Rig F-33443-3

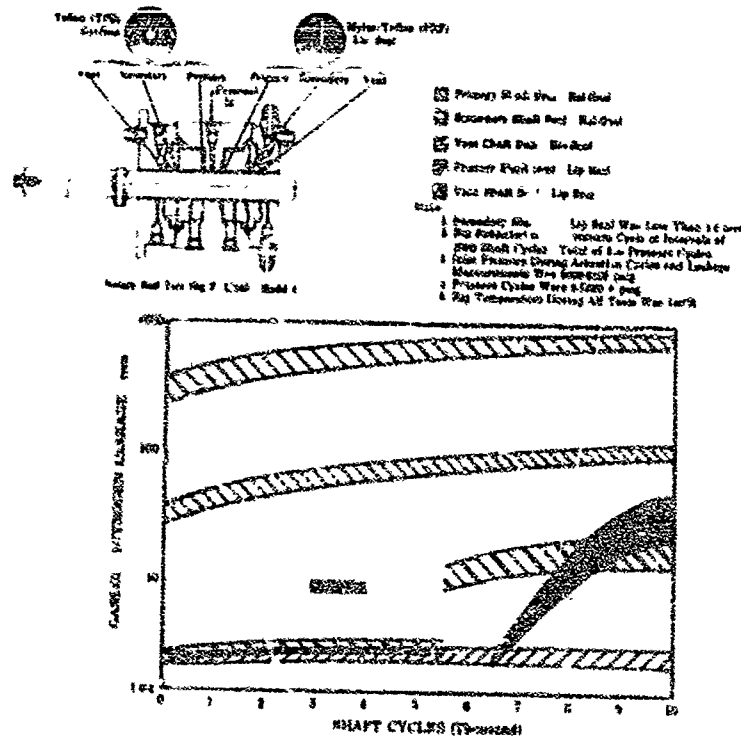
Figure 296. Rotary Shaft Seal Test Rig Leakage vs Cycles for Rig F-33443-4 FD 20075B

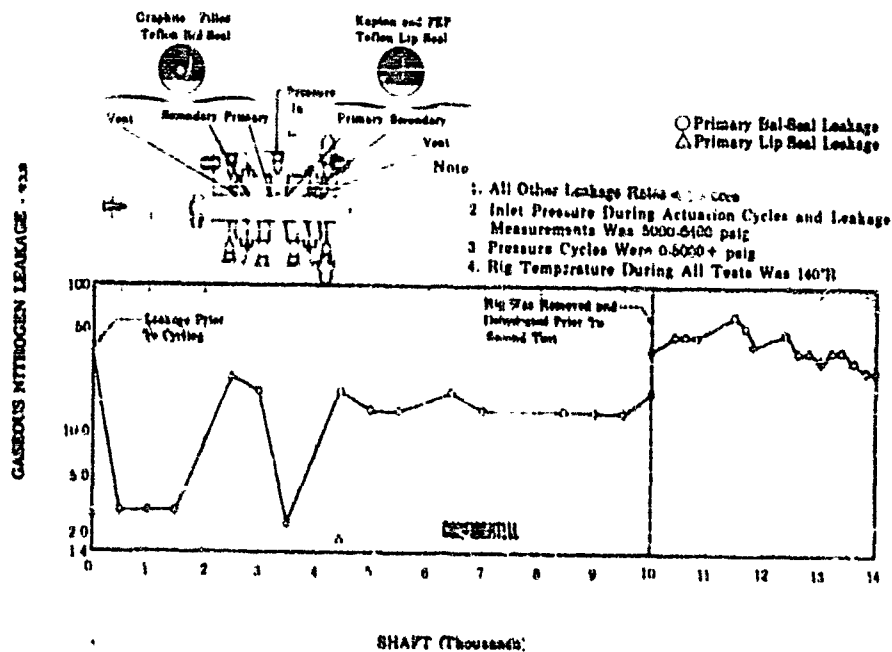
Figure 306. Rotary Shaft Seal Test Rig Leakage vs Cycles for Rig F-33443-7 FD 22234A

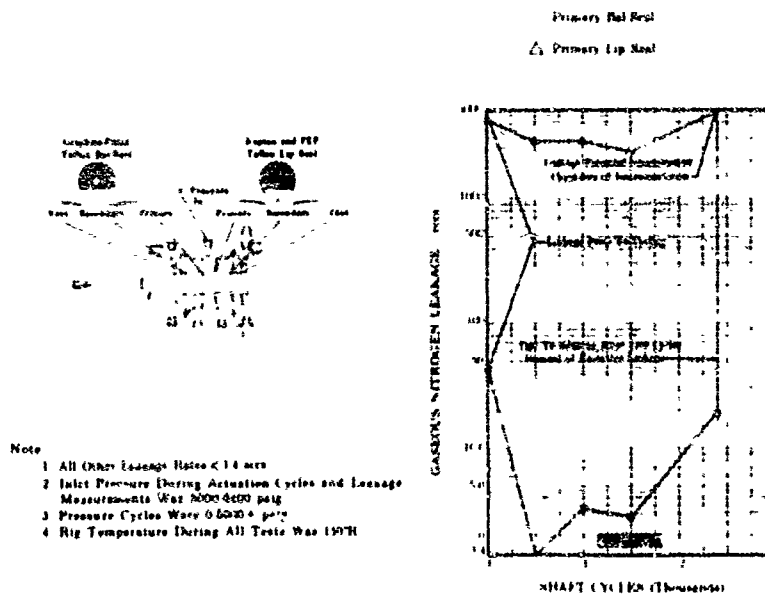
Figure 308. Rotary Shaft Seal test Rig Leakage vs Cycles for Rig F-33 43-8 FD 22578A

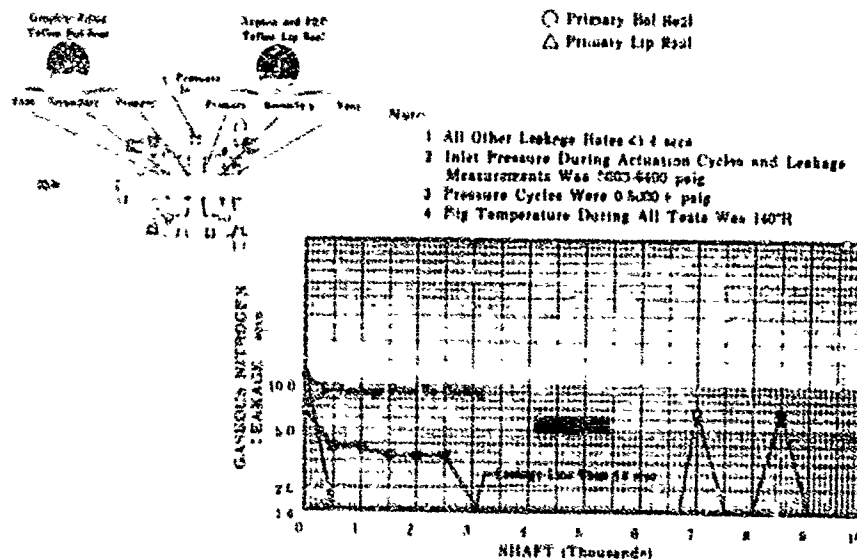
Figure 310. Rotary Shaft Seal Test Rig Leakage vs Cycles for Rig F-33443-9 FD 22579A

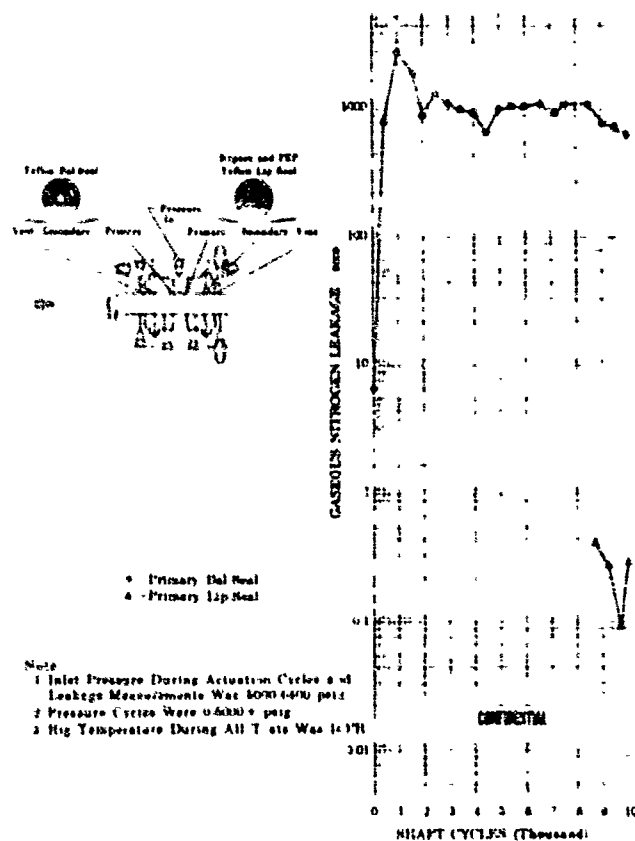
Figure 311. Rotary Shaft Seal Test Rig Leakage vs Cycles for Rig F-33443-10 FD 22749A

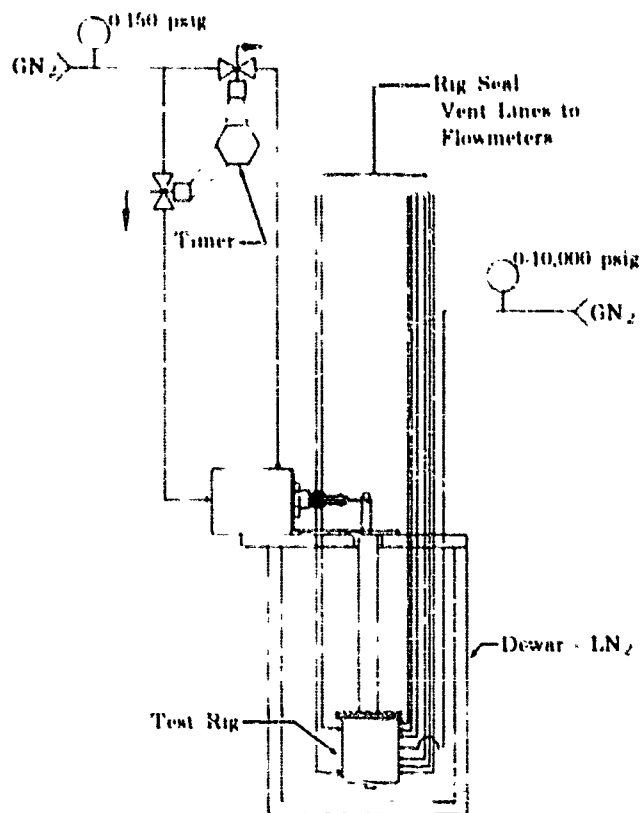
Figure 320. Rotary Shaft Seal Test Rig
Schematic for B-22 Stand

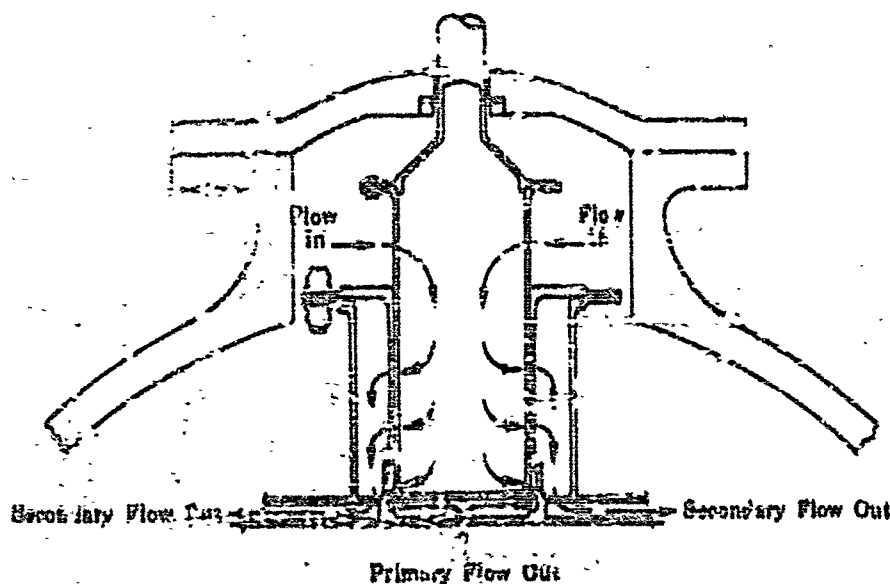
(b) Rotary sleeve valves are basically the same as sliding flat plate valves except that the ports are cut in concentric cylinders that are rotated relative to each other to vary area. This valve was eliminated from further consideration because of difficulty in sealing around the ports and failure to provide a positive shutoff. The performance of this scheme would be the same as the combination ball and sleeve except for the difference in entrance losses. (See figures 341 and 348.)

Figure 347. Flow Divider Valve, Rotary Sleeve Candidate

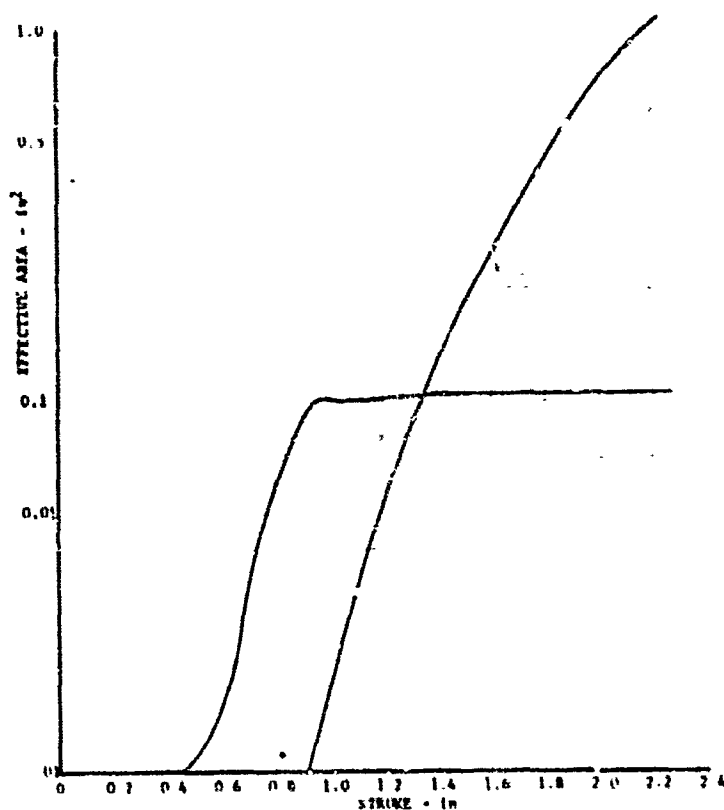
Figure 367. Preburner Oxidizer Flow Divider Valve (Predicted Effective Area vs Stroke)

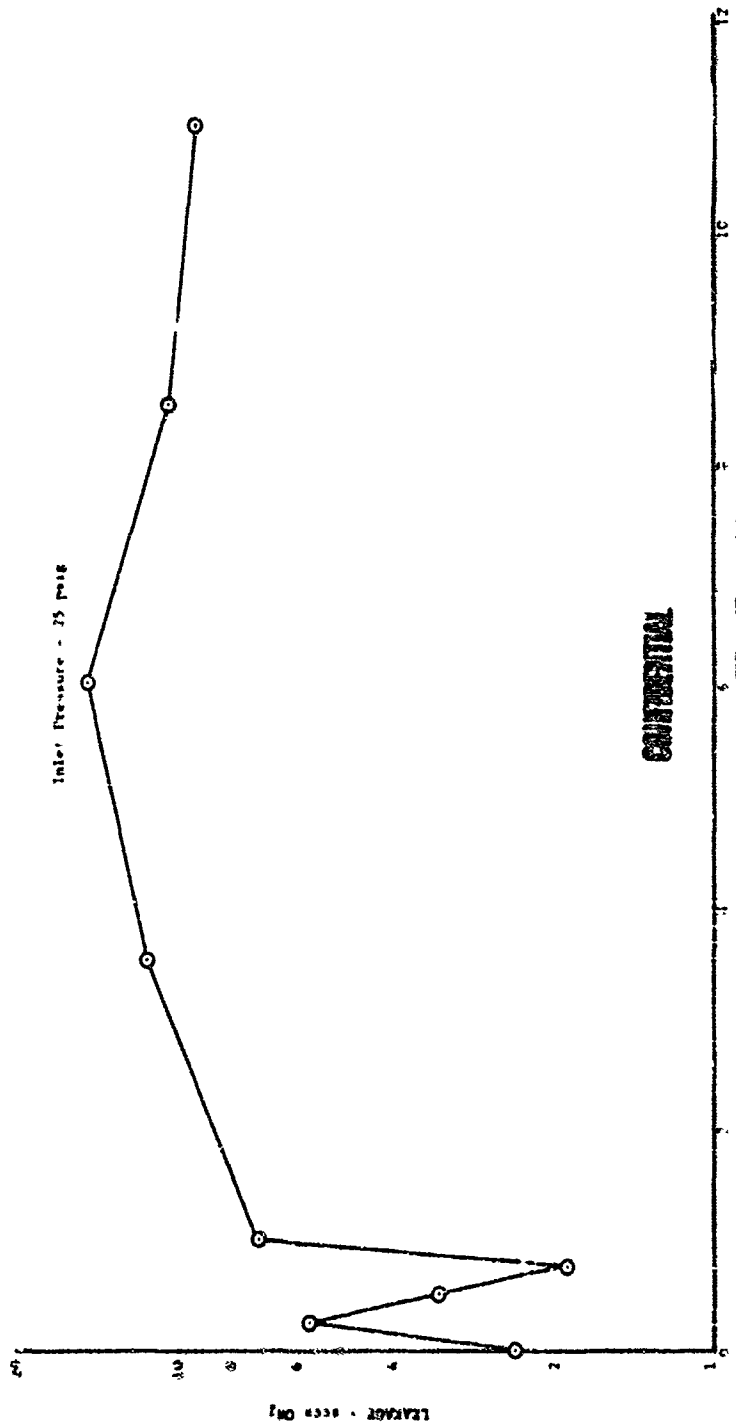
Figure 382. Teflon Shutoff Seal Leakage vs Cycles for Flow Divider Valve Rig F-33458-4

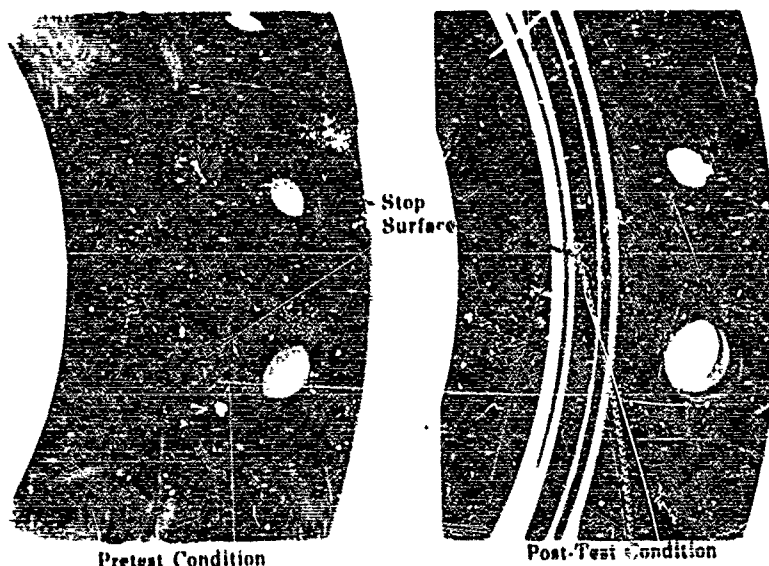
Figure 383. Pretest and Post-Test Condition of Shutoff Mechanical Stop Surface

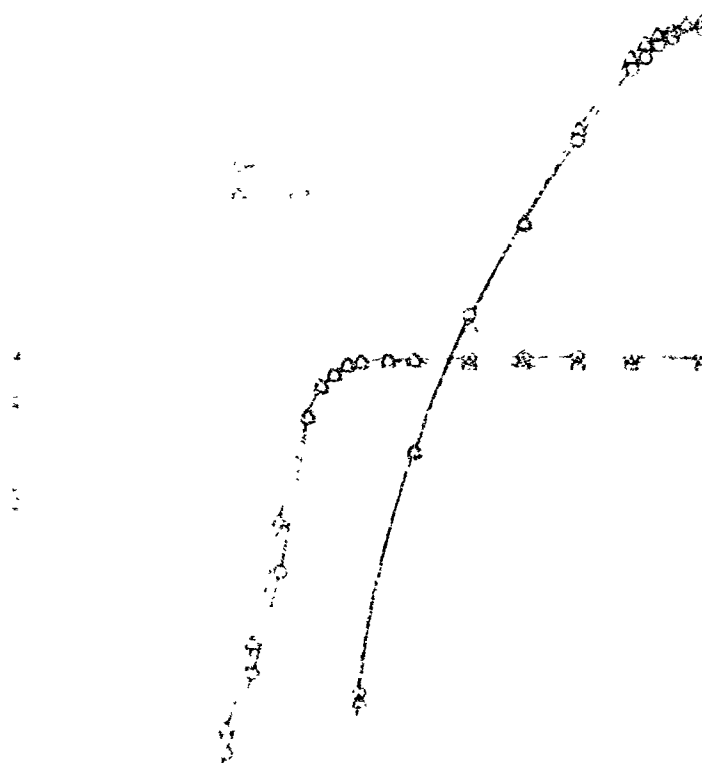
Figure 393. Flow Under Valve Effective Area vs Stroke - Rip F-33458

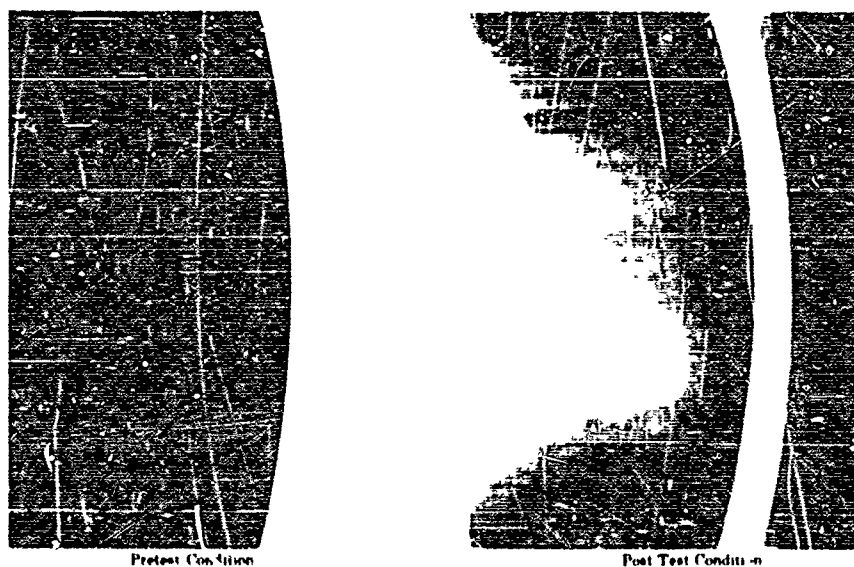
Figure 398. Pretest and Post-Test Condition of Lower Secondary Piston Ring FD 23021

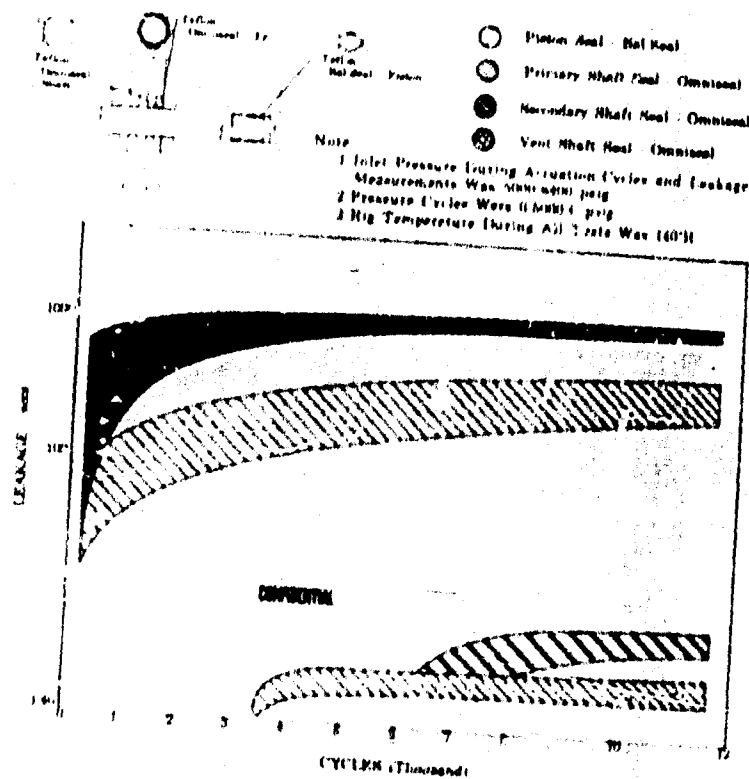
Figure 403. Piston Seal Test Rig Leakage vs Cycles for Rig F-33435-1

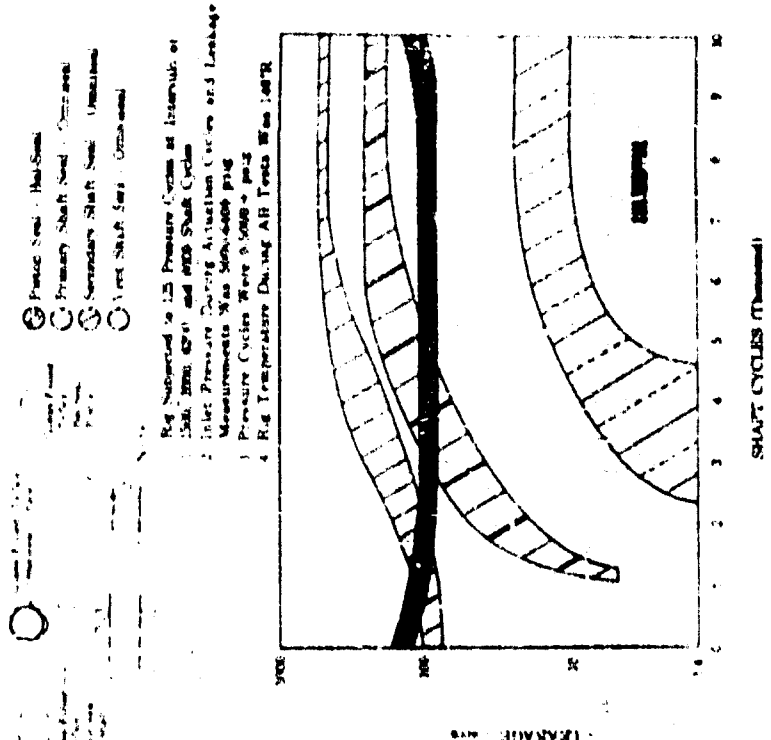
Figure 414. Piston Seal Test Rig Leakage FD 20178A vs Cycles for Rig F-33435-7

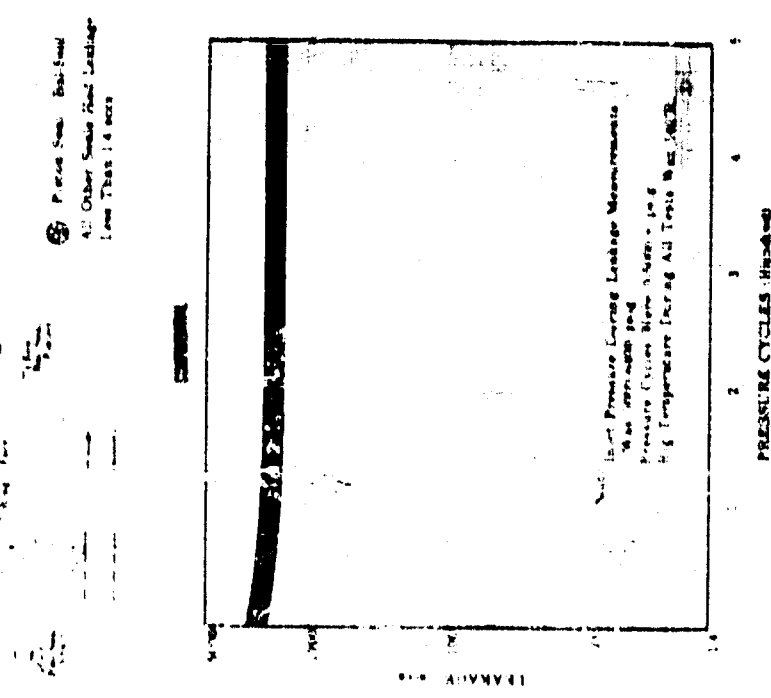
Figure 413. Piston Seal Test Rig Leakage vs Cycles for Rig F-33435-6A FD 20179A

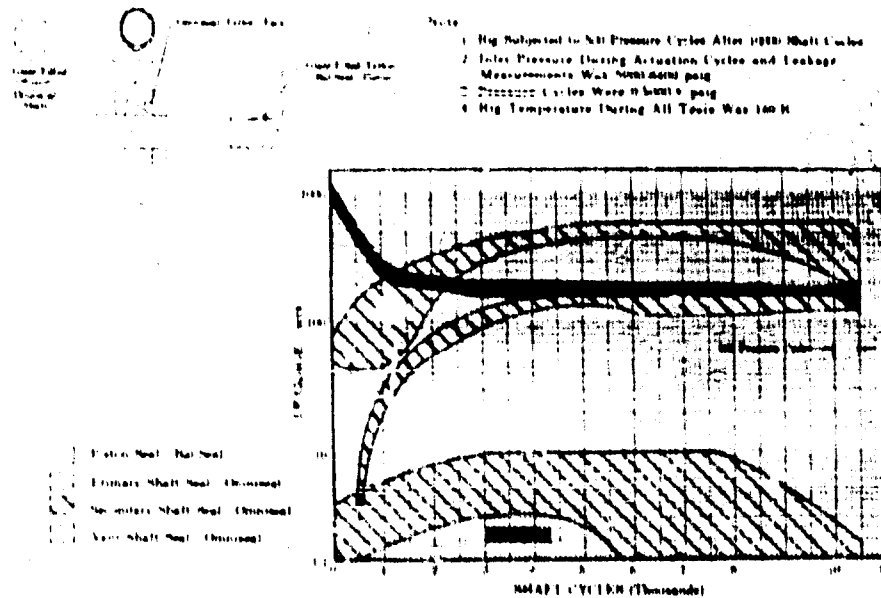
Figure 415. Piston Seal Test Rig Leakage vs Cycles for Rig F-33435-8

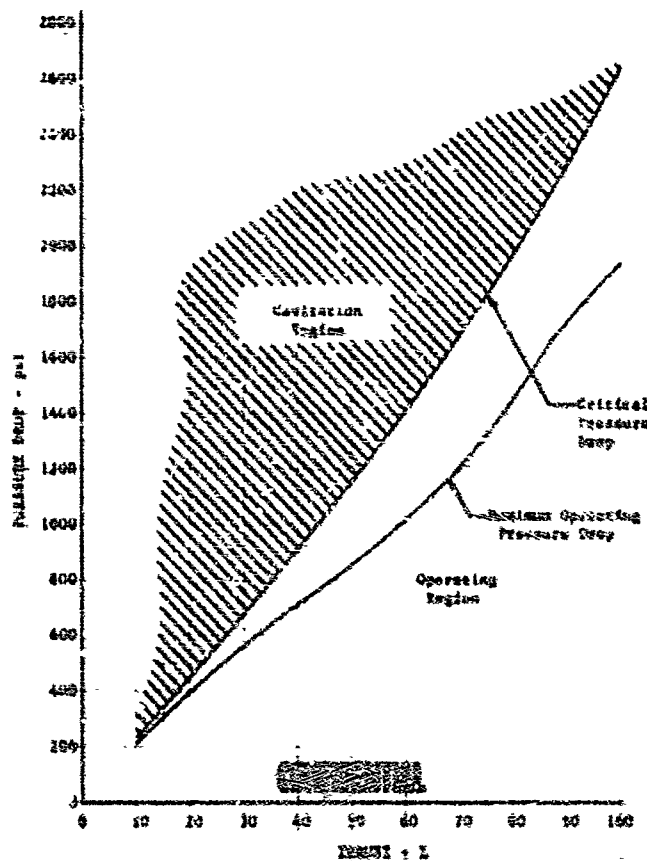
(U) The predicted thrust control valve operating characteristics are shown in figures 460 and 461.

Figure 460. Thrust Control Valve Pressure Drop vs Percent Thrust

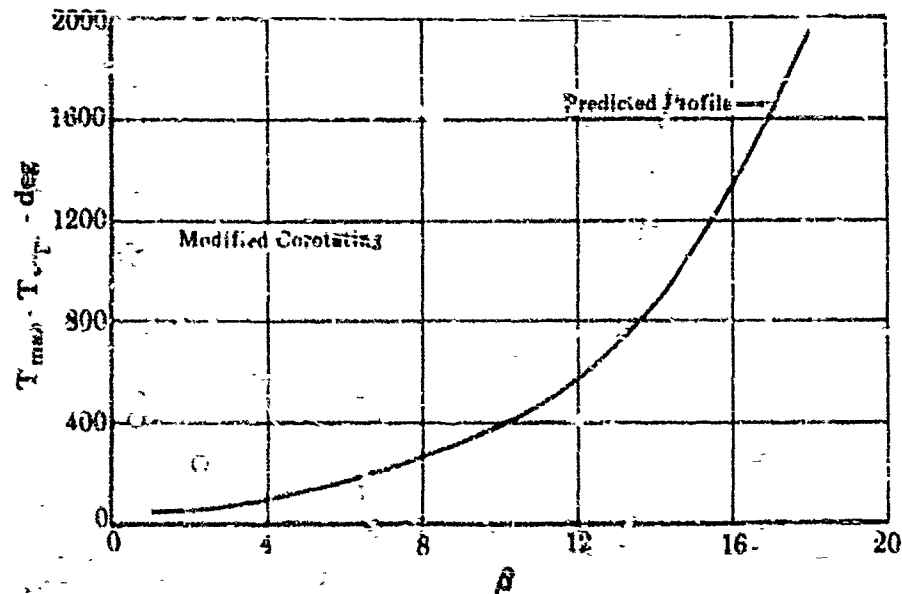
Figure 499. Fuel Element Temperature Profile - FD 23452
Concluded

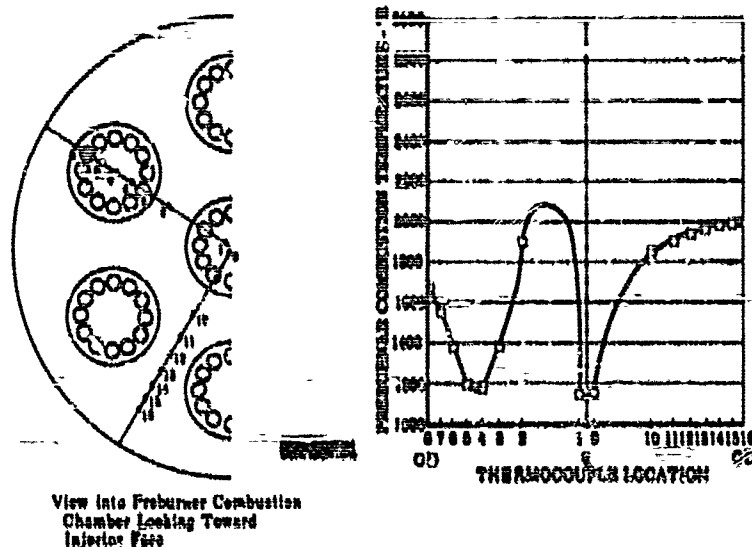
Figure 502. Temperature Profile for Tent No. 51 FD 23042

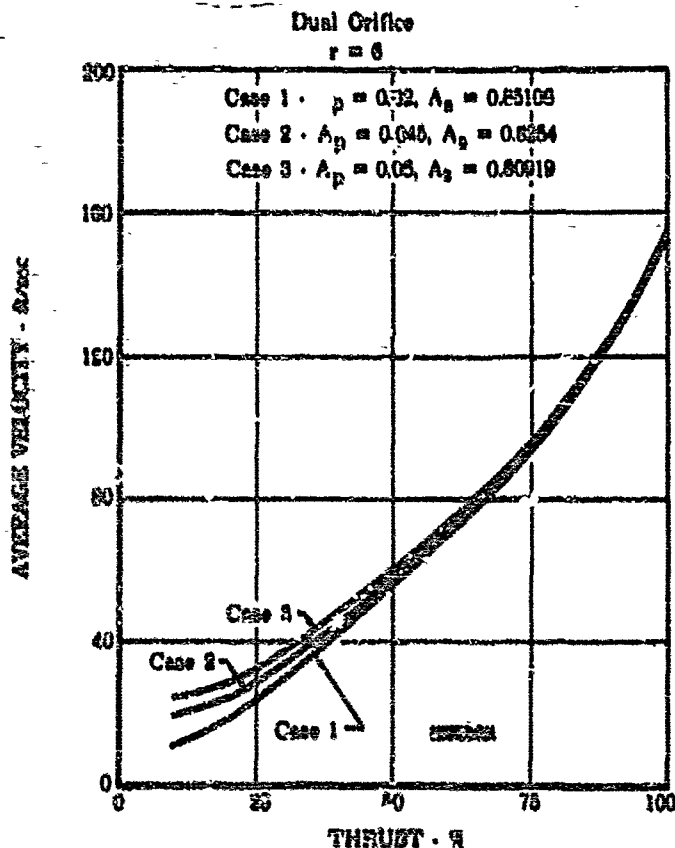
Figure 505. Variation in Velocity With Thrust

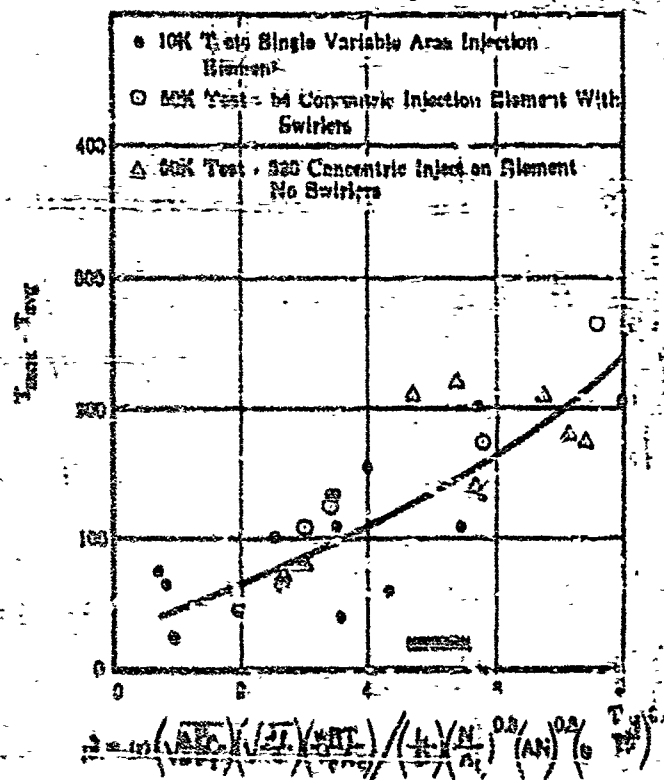
Figure 508. Correlation of Injector and Combustion Chamber Parameters vs Temperature Profile
